SITE CONTOUR PLAN
A1 @ SCALE 1 : 200

ELITE
SITE ANALYSIS

PROJECT: FEATURE & LEVELS SURVEY.
CLIENT: ELITE Site Analysis.
LOCATION: EXAMPLE ROAD, EXAMPLE
DATE: N/A DRAWN: sdb TITLE: Final Drawing VERSION: A
JOB NO: Example DWG NO: A0#

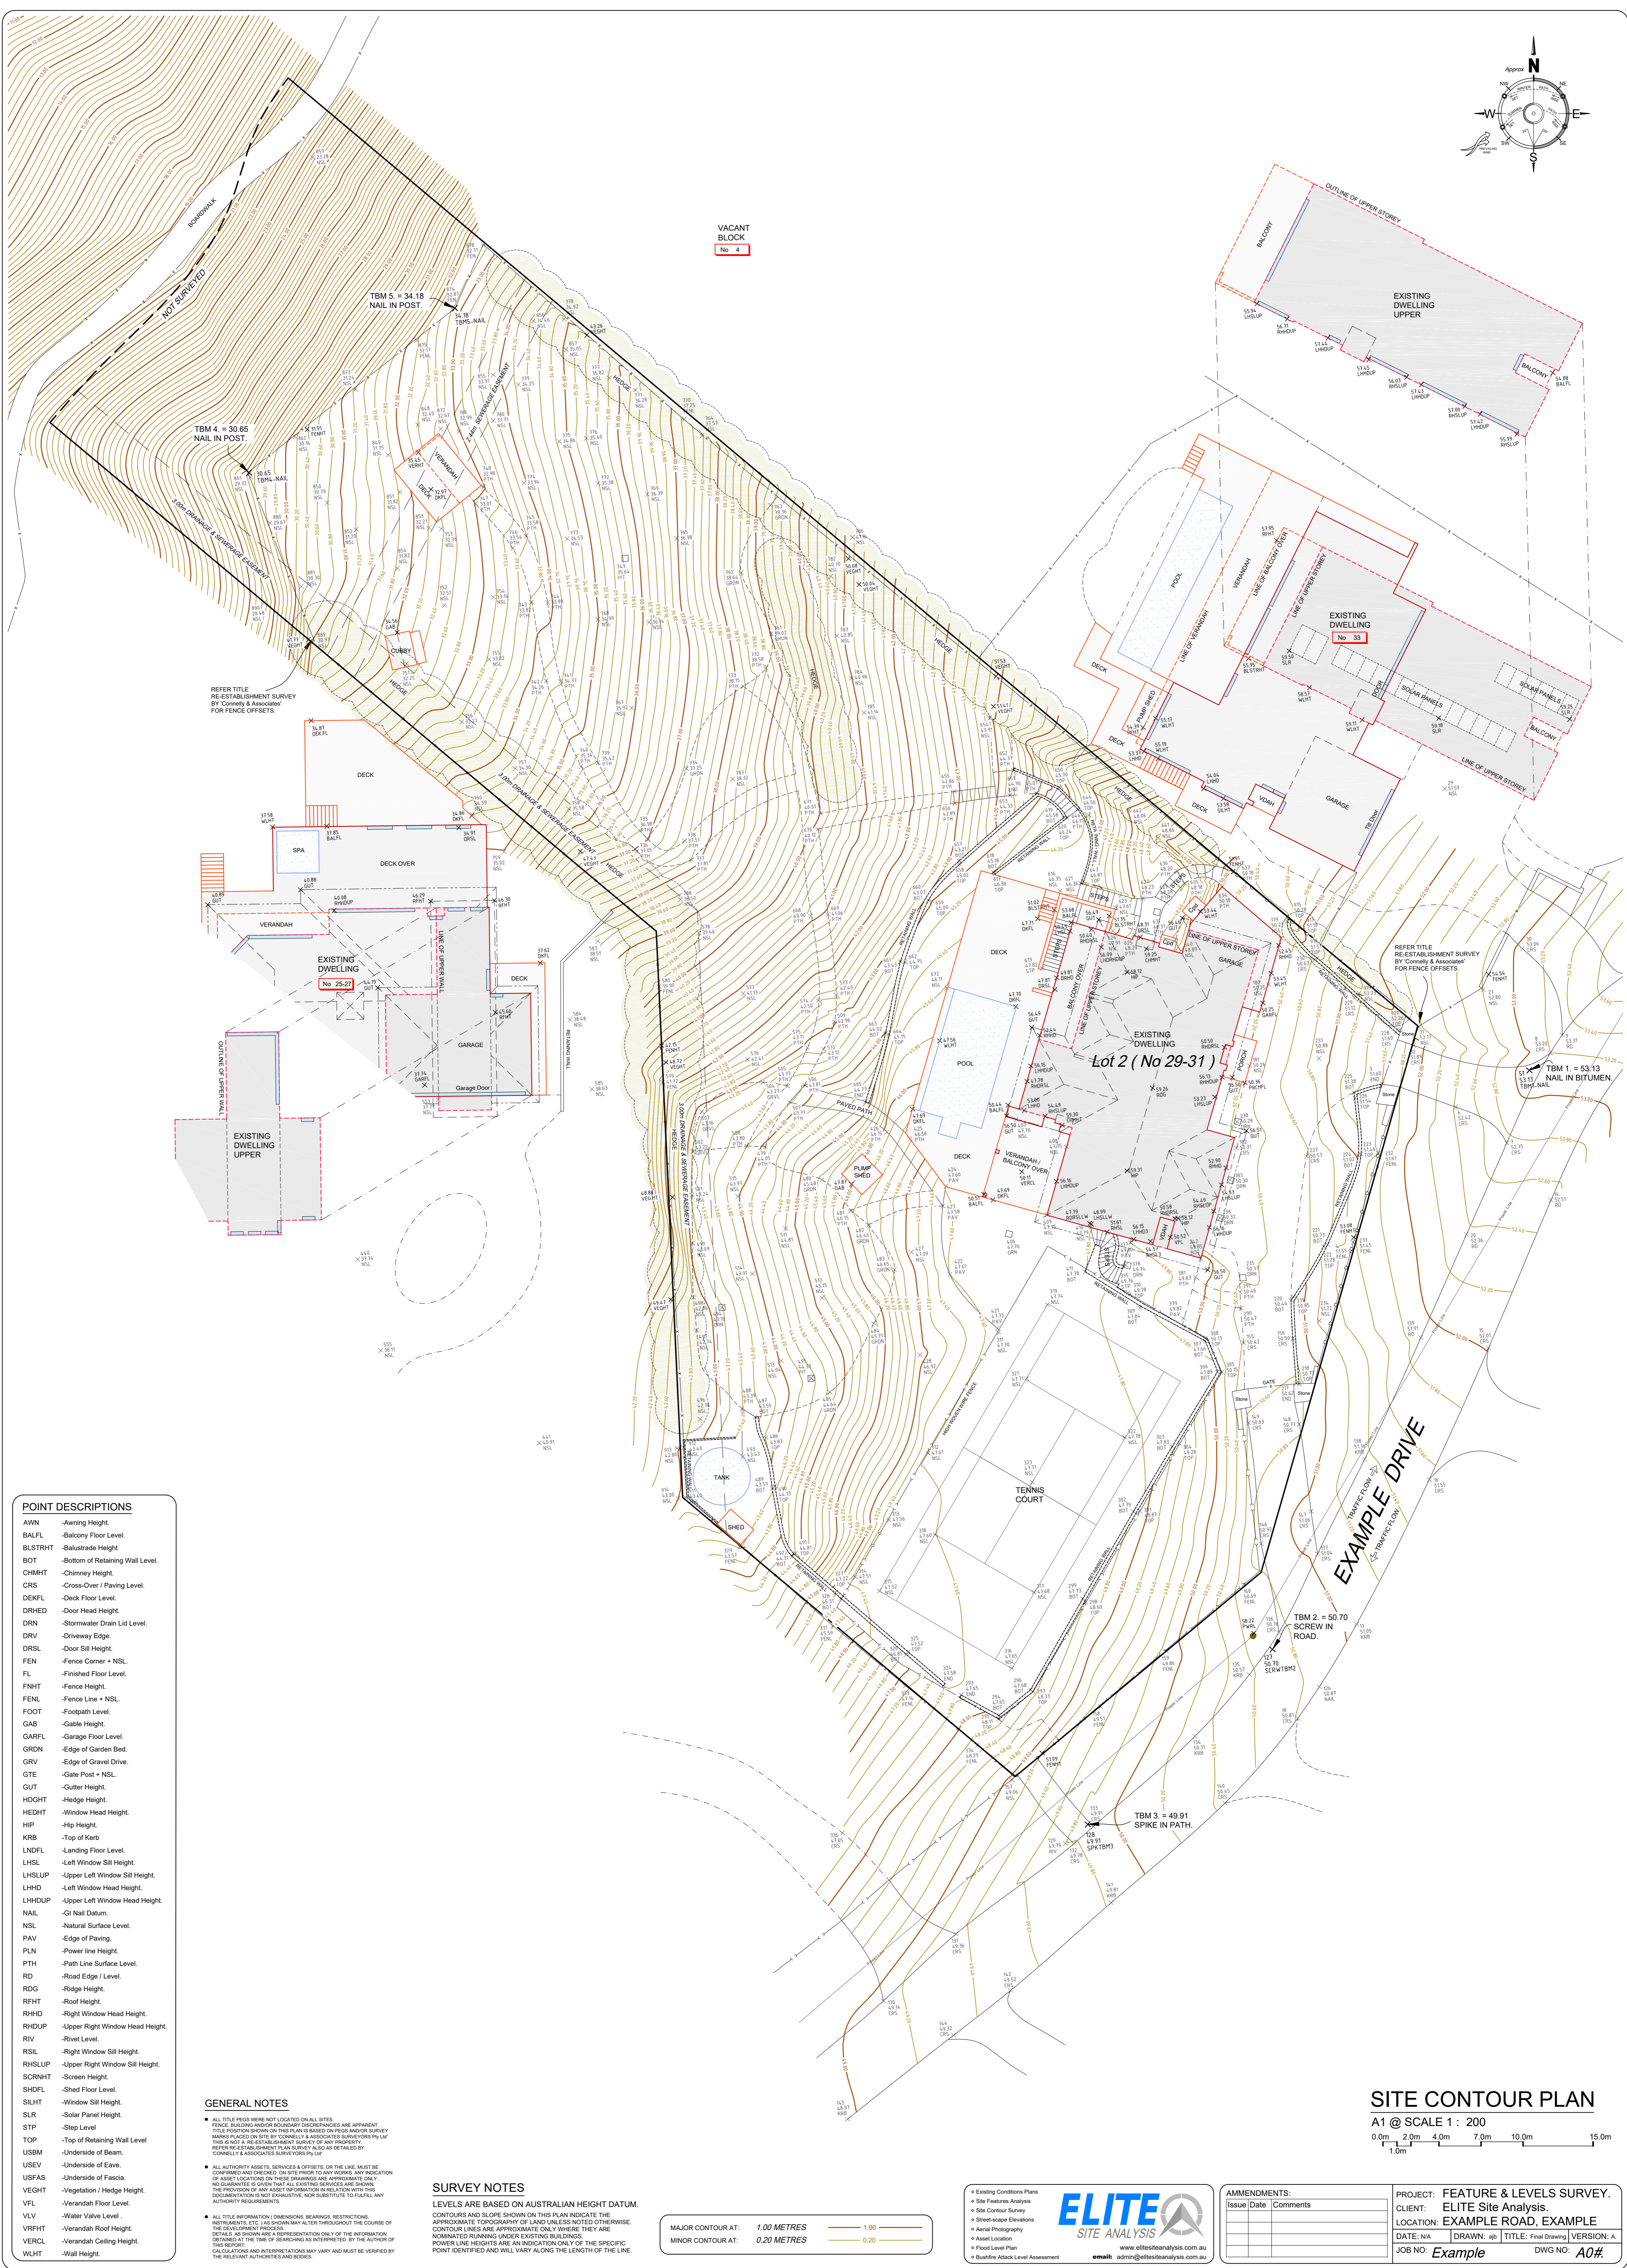
LEVELS ARE BASED ON AUSTRALIAN HEIGHT DATUM.

CONTOURS AND SLOPE SHOWN ON THIS PLAN INDICATE THE APPROXIMATE TOPOGRAPHY OF LAND UNLESS NOTED OTHERWISE. CONTOUR LINES ARE APPROXIMATE ONLY WHERE THEY ARE NOMINATED RUNNING UNDER EXISTING BUILDINGS. POWER LINE HEIGHTS ARE AN INDICATION ONLY OF THE SPECIFIC POINT IDENTIFIED AND WILL VARY ALONG THE LENGTH OF THE LINE.

MAJOR CONTOUR AT:	1.00 METRES	1.00
MINOR CONTOUR AT:	0.20 METRES	0.20
